# SOMETHING ABOUT METEORITES: WHEN CORROSION PREVENTION CAUSES CORROSION

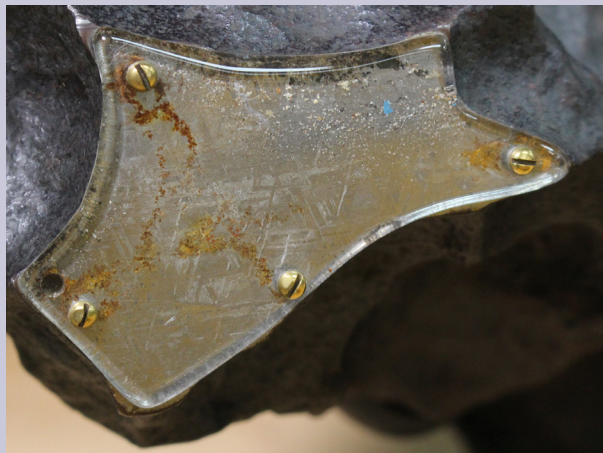
The Gibeon meteorite specimen NHMUK BM.1930,422 at the Natural History Museum in London is a 136 kg IVA iron fine octahedrite find from Great Nama Land, Namibia (Africa) with a polished face showing Widmanstätten/Thomson pattern. The specimen had been on loan for 3 years on open display exposed to environmental change and frequently touched by visitors. The fusion crust is stable but the real area of concern was the polished section at the top of the specimen. This was significantly marred by corrosion underneath its Polymethyl methacrylate (Perspex) cover (*left*).

The Perspex cover had been attached to the polished section to prevent contamination from visitor's hands because chlorides from sweat residues will accelerate iron corrosion. However, iron oxides have formed below the cover. This is likely due to condensation of atmospheric water below the cover plus establishment of electrochemical cells due to the presence of the screws. Re-polishing the surface was considered unsuitable in this instance so several chelating gels were trialled to remove the corrosion products. The chelators were added to gels made from Laponite RD or Methyl cellulose to ensure the localised control of chemical reactions and reduce evaporation rates:

The most effective treatment proved to be DTPA and Tiron in a Methyl cellulose gel, applied for 30 minutes then cleared with swabs and pure water.

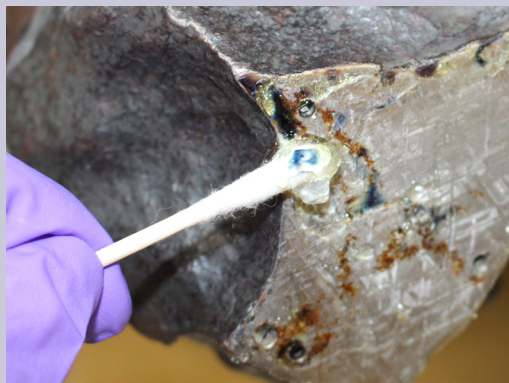
*The corrosion products turned black after reaction with DTPA and Tiron, which was extremely satisfying...*

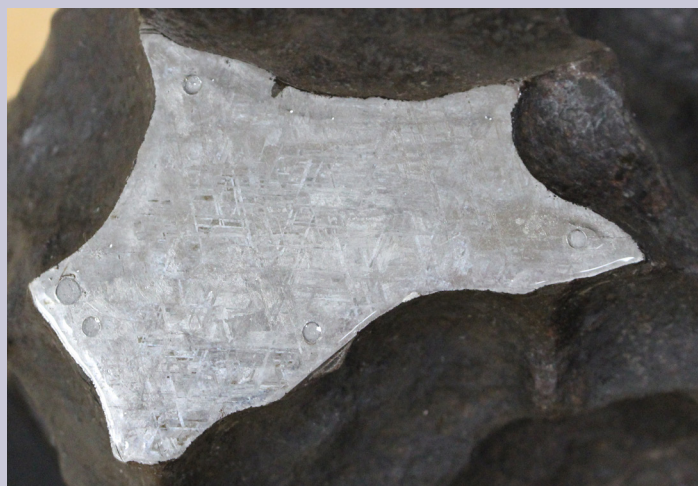
*The polished section following treatment.*

Unfortunately, even though all of the oxidation products were removed, the pitting caused by the initial corrosion had marred the appearance of the surface. The surface was therefore re-etched using a cotton swab dipped in nitric acid.

Finally the screw-holes were filled with Laropal A81 and glass microballoons tinted with acrylic paints and the entire polished section was coated with Laropal A81 (20% in 1:4 isopropanol:white spirit) to protect it from future corrosion (Digney-Peer et al. 2012).
